WRDC-TR-89-4055

COMPENDIUM OF FRACTOGRAPHIC DATA FOR COMPOSITE
MATERIALS

INTERIM REPORT
Covering 9-22-86 through 10-31-88

C. Hua
M. Yamashita
Boeing Advanced Systems
P.O. Box 3707
Seattle, WA 98124

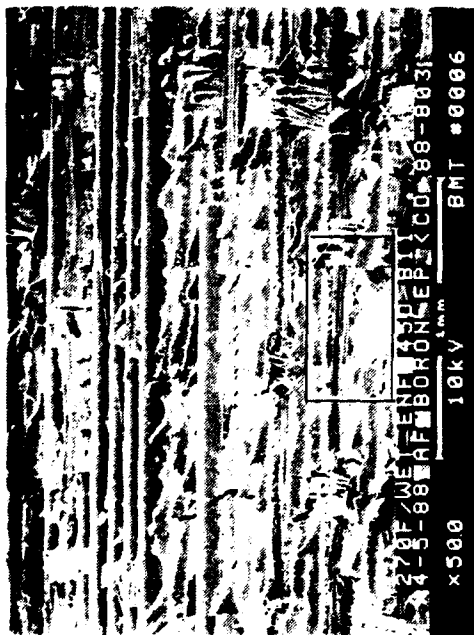
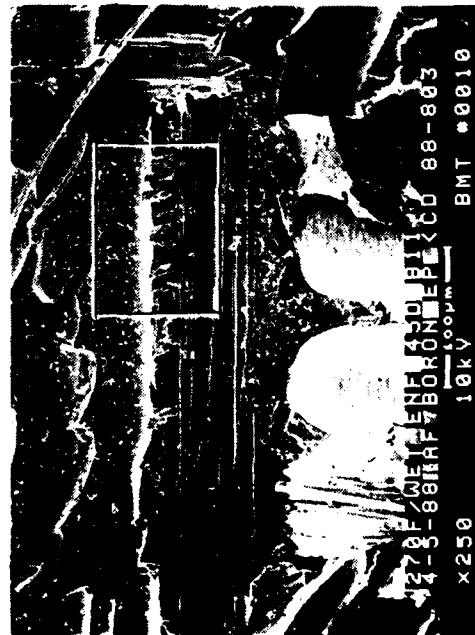
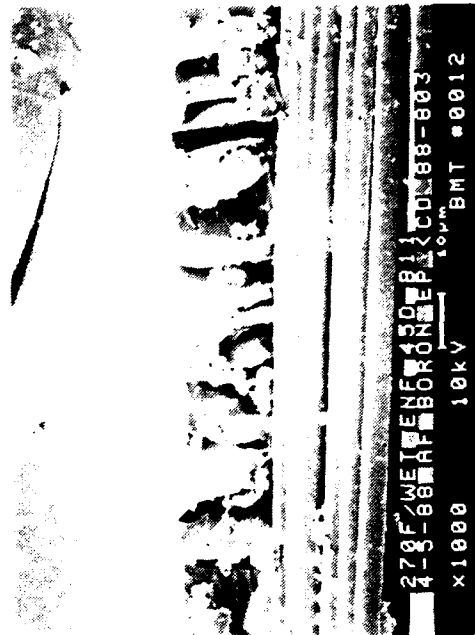
Figure 4.4-116. SEM Fractographs of 270 F/Wet, Interlaminar Mode II Shear Fracture in Boron/Epoxy

Figure 4.4-116 illustrates the SEM fractograph of the interlaminar Mode II shear specimen exposed to humidity and tested at 270°F. The fracture surface showed hackles throughout the specimen. Poor fiber/matrix adhesion was observed, which is typical for shear fractures.

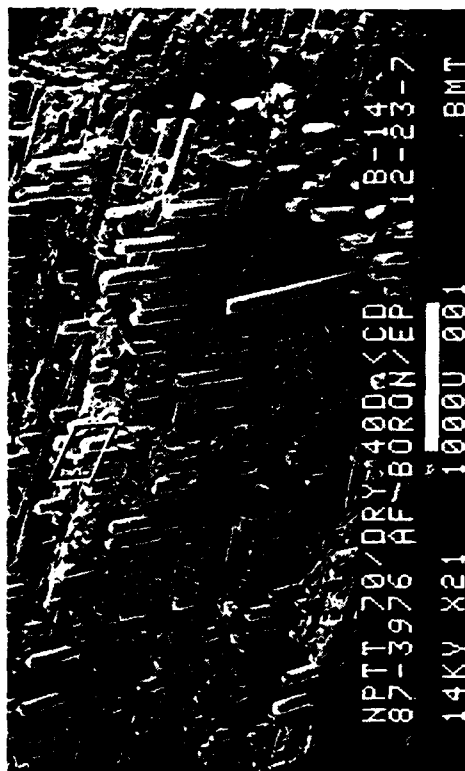
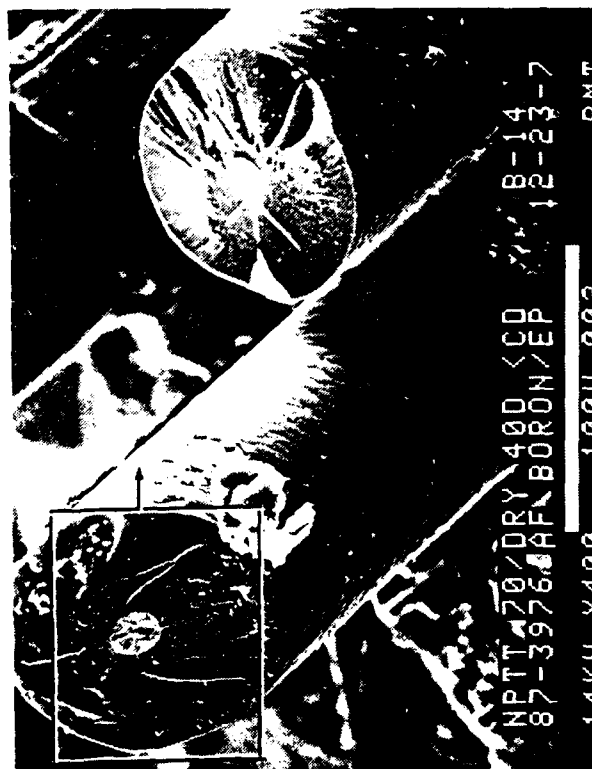
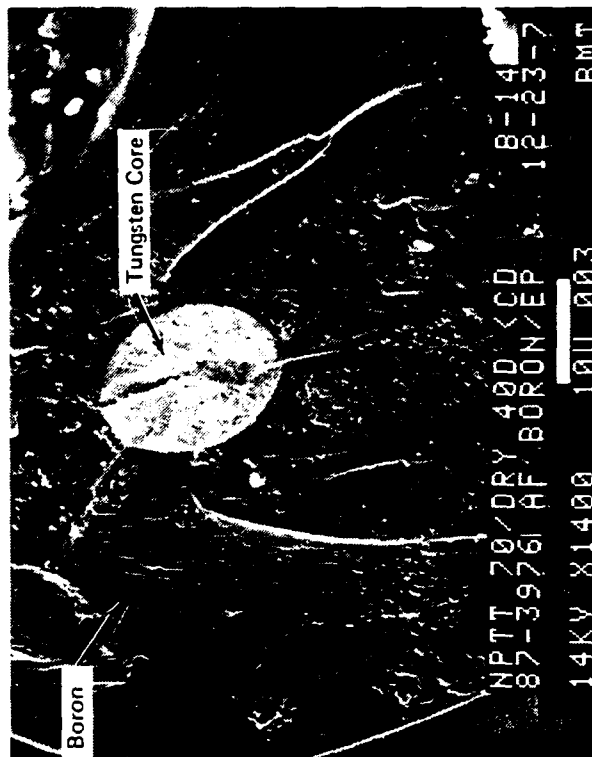
Figure 4.4-117. SEM Fractographs of Room Temperature/Dry, Translaminar Tension Fracture in Boron/Epoxy

The SEM analysis showed that the adhesion at the interface between the boron fibers and the epoxy matrix was poor at the time of the fracture. This was also evidenced by the fiber pullouts (Fig. 4.4-117).

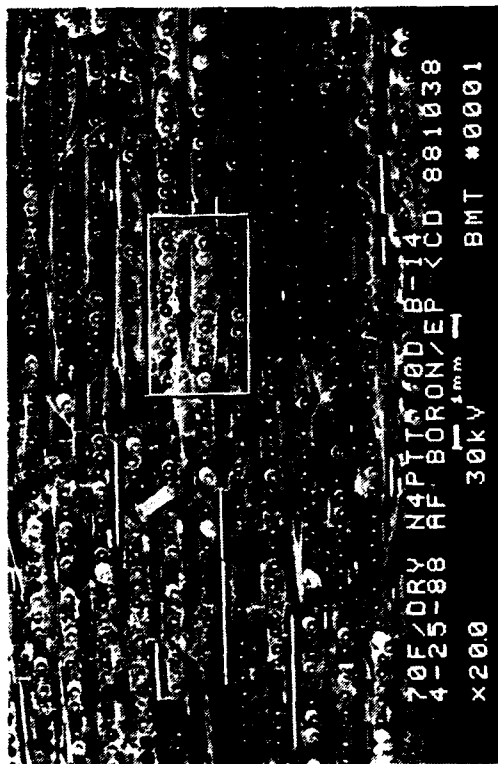
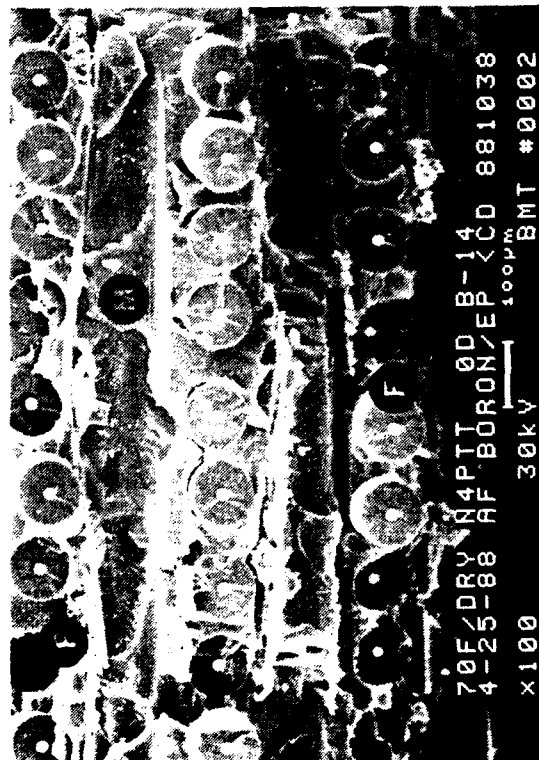
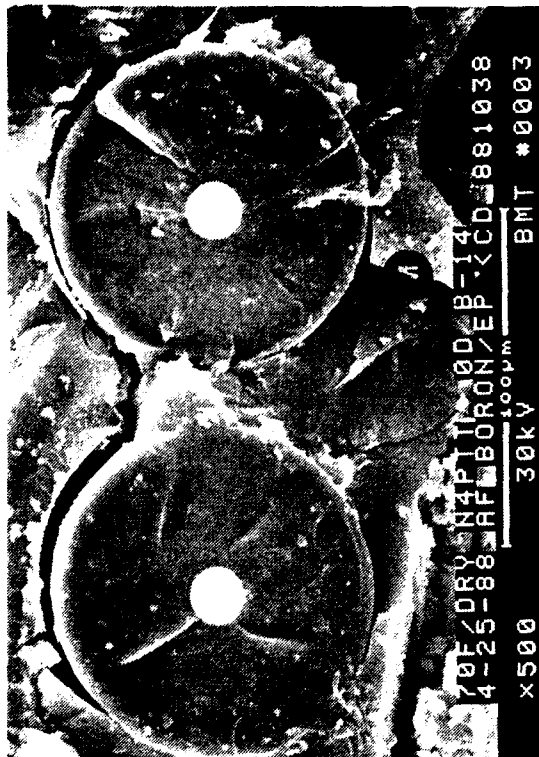
Figure 4.4-118. SEM Fractographs of Room Temperature/Dry, Translaminar Tension Fracture in Boron/Epoxy; Shown at 0 Degree Tilt

Unlike those in glass and carbon fibers, the radial patterns on the boron fiber ends initiated at the tungsten core/boron interface (Fig. 4.4-118). This phenomenon may be due to the lower interfacial shear strength of the tungsten core/boron interface in comparison with the boron fiber/epoxy interface. The fracture features radiating from the center of the boron-tungsten fiber could not be used to determine the crack propagation direction. Cracks in glass and carbon fibers typically initiate at the outer surface and propagate from one fiber to another, and the average of the individual crack directions indicates the overall crack direction.

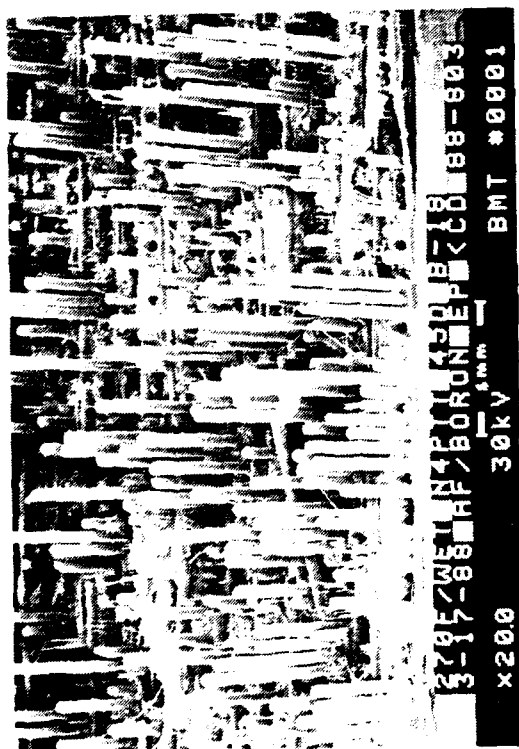
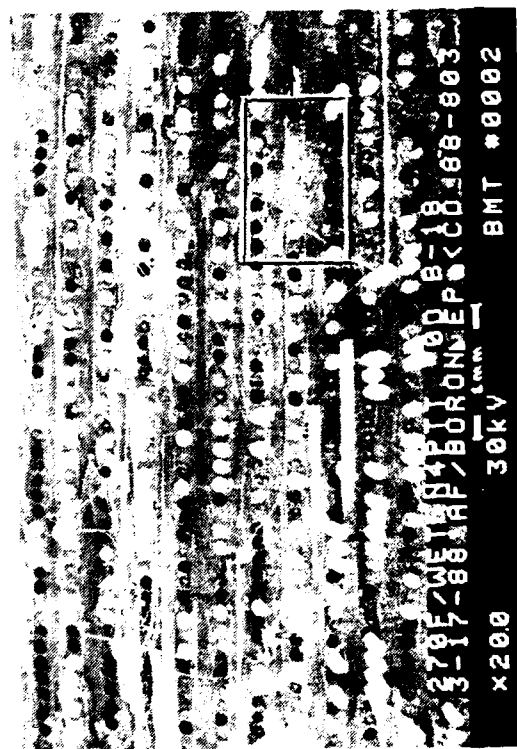
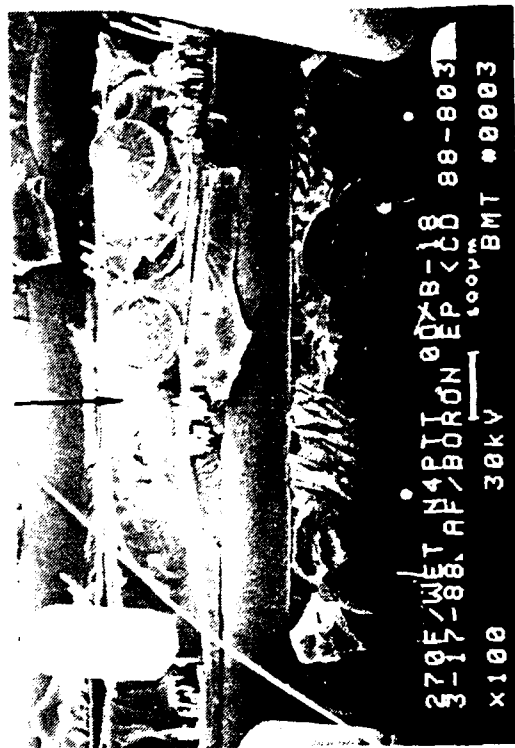
Figure 4.4-119. SEM Fractographs of 270 FWet, Translaminar Tension Fracture in Boron/Epoxy; Shown at 45 and 0 Degree Tilts

the fracture was fiber-dominated. The fracture surface exhibited many holes in the matrix, indicative of extensive fiber pullout (poor fiber/matrix adhesion). Additionally, the fibers pulled away from the matrix were much longer than those in the RT/dry specimen. This also indicating poor fiber/matrix adhesion (Fig. 4.4-119).

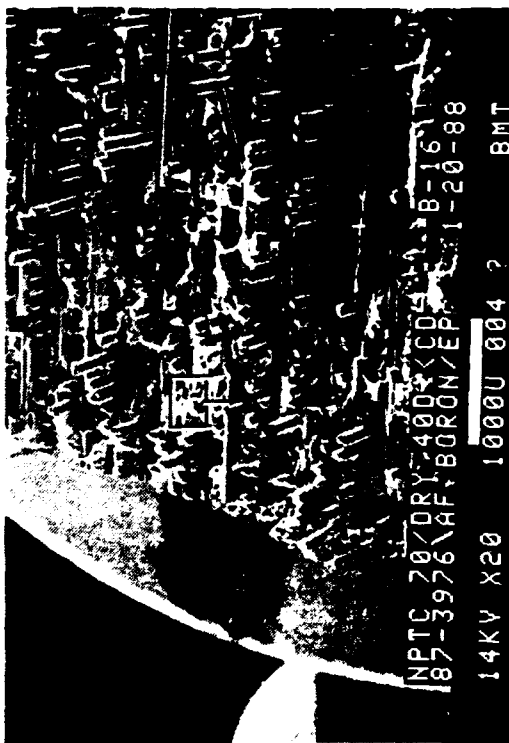
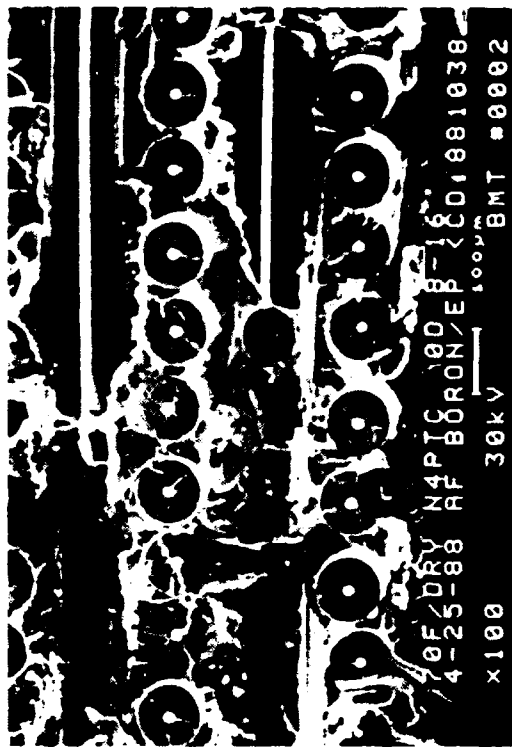
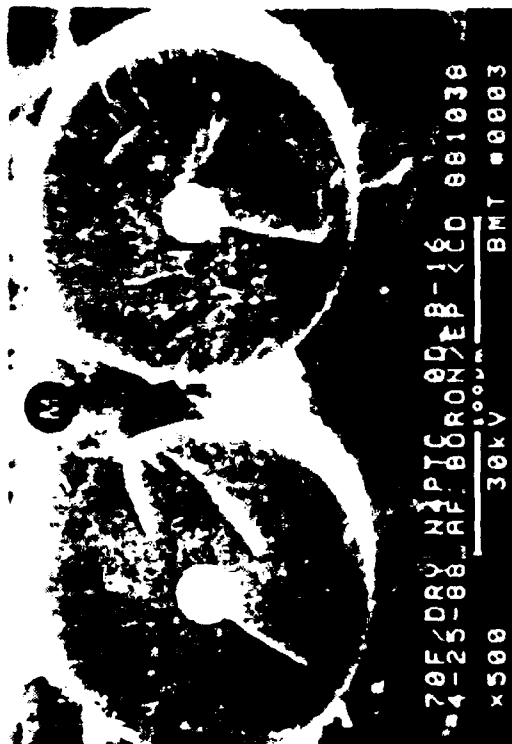
Translaminal Compression, RT/Dry. Visual observation revealed numerous protruded boron-tungsten filaments. SEM analysis shown in Figures 4.4-120 and 4.4-121 confirmed the visual result. Unlike the glass and carbon fibers, the boron-tungsten fibers exhibited similar fracture features in both tension and compression specimens. This may be due to the higher ductility of the boron-tungsten fibers in comparison with the glass and carbon fibers. This eliminates the microbuckling effects (from compression) typically exhibited in fibers with higher stiffness. The neutral axes observed on the glass and carbon fiber ends were not present on the boron-tungsten translaminal compression specimen tested under RT/dry condition.

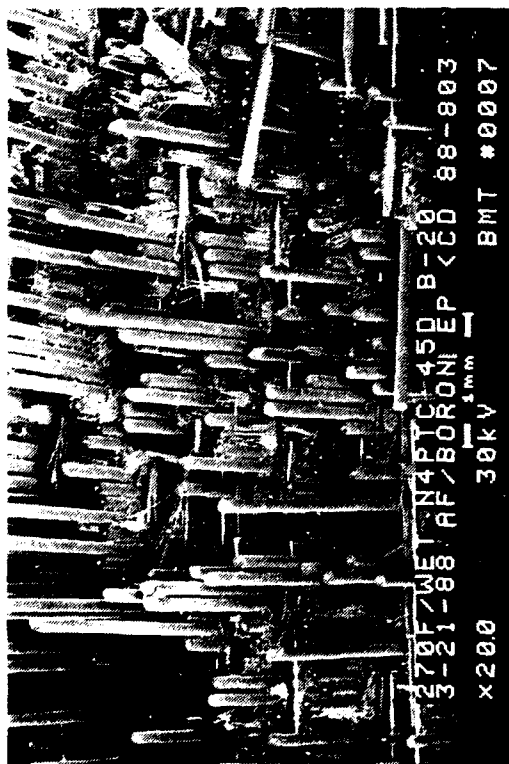
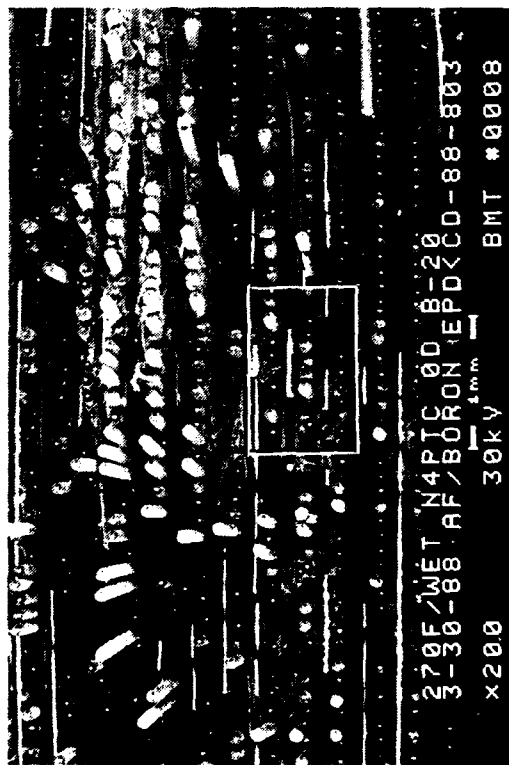
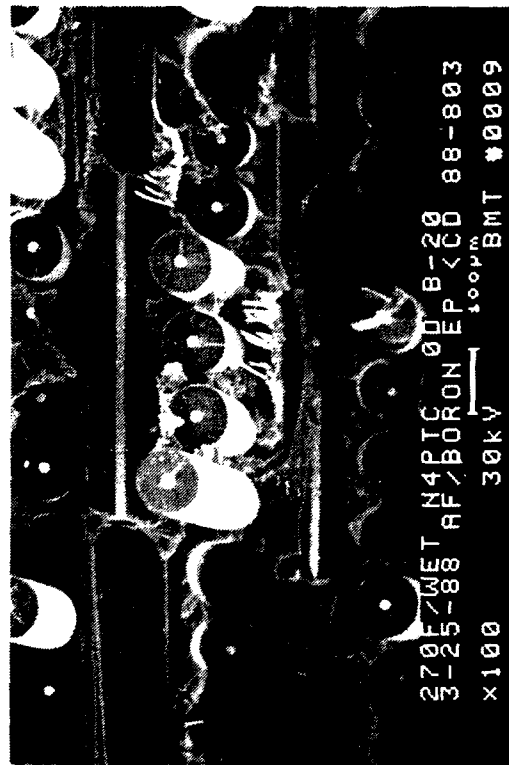
Figure 4.4-122. SEM Fractographs of 270 F/Wet, Translaminar Compression Fracture in Boron/Epoxy

Translaminal Compression, 270°F/Wet. Visual examination revealed a fracture surface with numerous protruding fibers, similar to the fracture surface of the tension specimen. The ends of the boron filaments exhibited radial patterns similar to those of the translaminal compression RT/dry specimen (Fig. 4.4-122). Boron fiber pullouts exhibited little residual resin on the fiber due to weak fiber/matrix adhesion; also, the boron fiber surface was not as smooth as is typical of carbon fiber (Fig. 4.4-123). This is due to the chemical deposition process of boron onto the tungsten core. The neutral axes typically observed on glass and carbon fiber ends, a result of microbuckling, were not present on the boron-tungsten translaminal compression specimen tested under 270°F/wet conditions.

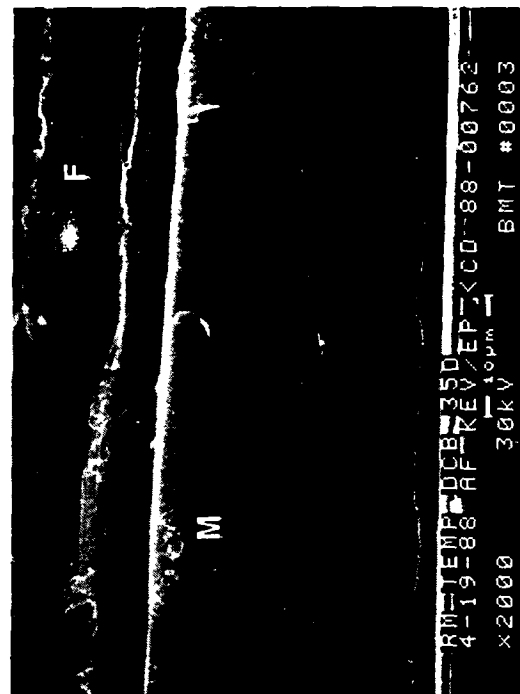
Figure 4.4-124. SEM Fractographs of Room Temperature, Interlaminar Mode I Tension Fracture in Kevlar/Epoxy (at the Center of the Weave)

Interlaminar Mode I Tension, RT/Dry. The RT/dry interlaminar fracture lacked rivermarks commonly observed in other epoxy-based interlaminar Mode I tension fractures (such as in glass or carbon-fiber reinforced specimens). There were no fracture features at the node or the center of the weave that could be used for determining the crack propagation direction (Fig. 4.4-124 and 4.4-125). The fiber/matrix adhesion was poor.

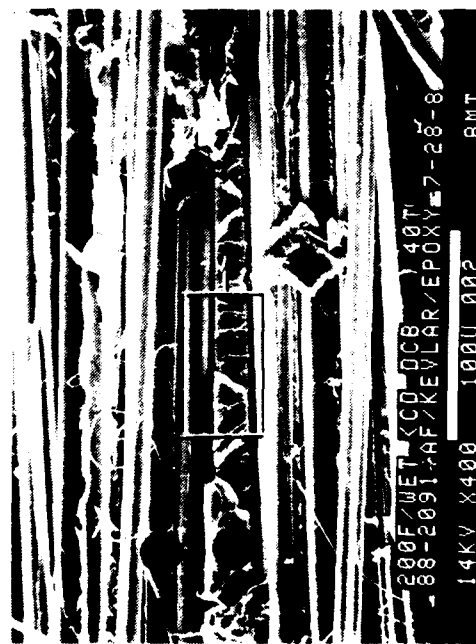
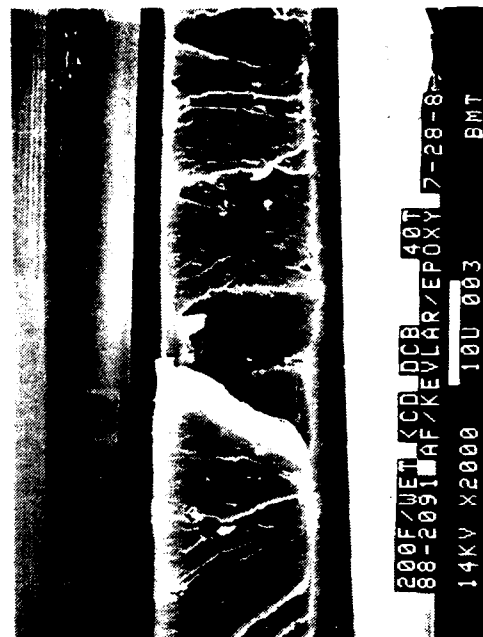
Figure 4.4-126. SEM Fractographs of 200 F/Wet, Interlaminar Mode I Tension Fracture in Kevlar/Epoxy

Interlaminar Mode I Tension, 200°F/Wet. Visual examination of the 200°F/wet interlaminar Mode I tension fracture revealed a smooth, shiny surface with patches of flakey resin on the fracture. The fractures of the RT/dry and 200°F/wet specimens appeared almost identical except for an apparent degradation in the patches of flakey resin on the 200°F/wet fracture. The fiber/matrix adhesion was poor as evidenced by the smooth fracture with fiber imprints. The difference between the RT/dry and the 200°F/wet specimens was the greater extent of fiber pullouts and fiber imprints in the 200°F/wet. This indicated weaker fiber/matrix adhesion than in the RT/dry specimen (Fig. 4.4-126).

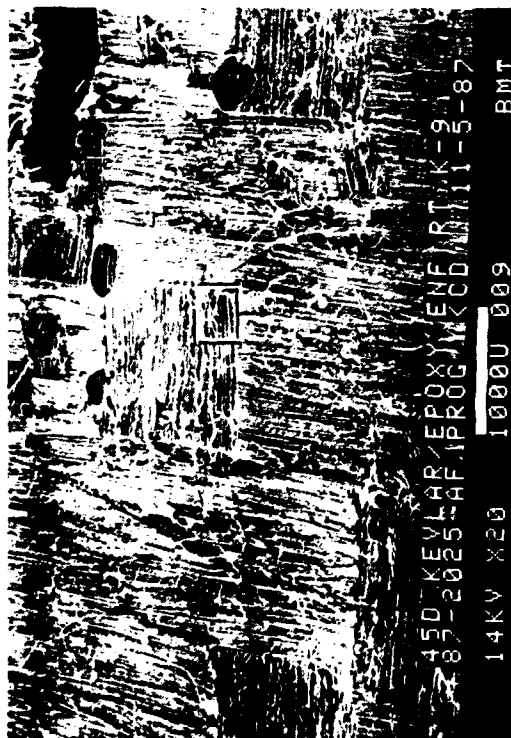
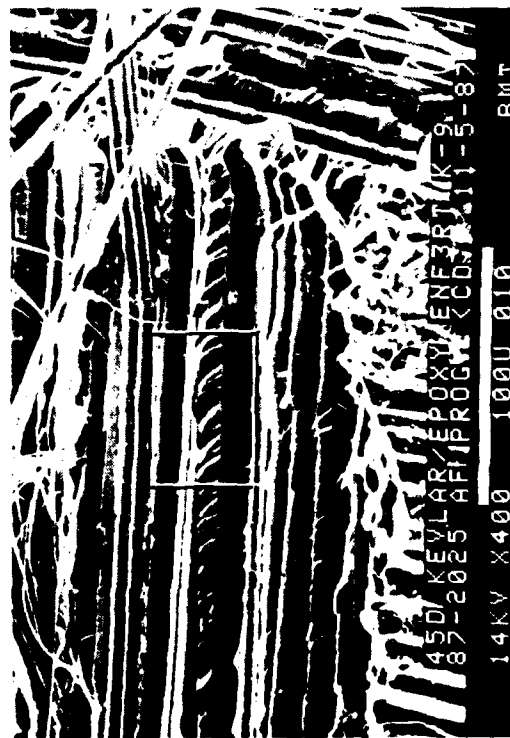
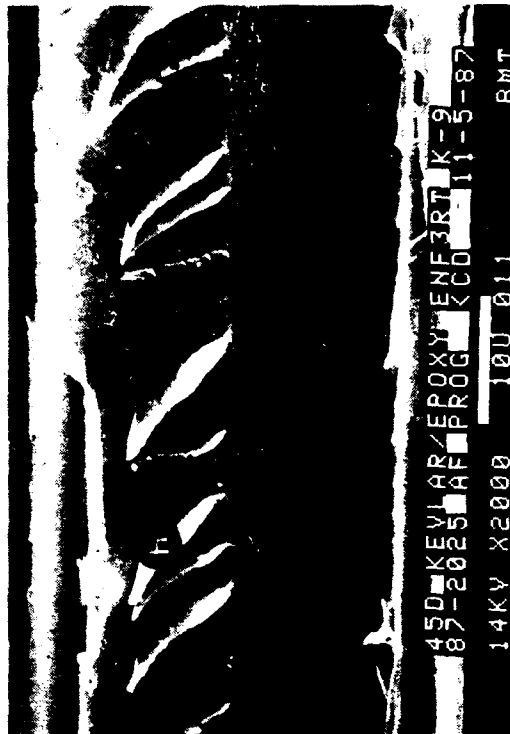
Figure 4.4-127. SEM Fractographs of Room Temperature, Interlaminar Mode II Shear Fracture in Kevlar/Epoxy Fabric

SEM analysis showed hackle formation and an adhesive-type fracture evidenced by the clean and smooth imprints of the fibers (Fig. 4.4-127).

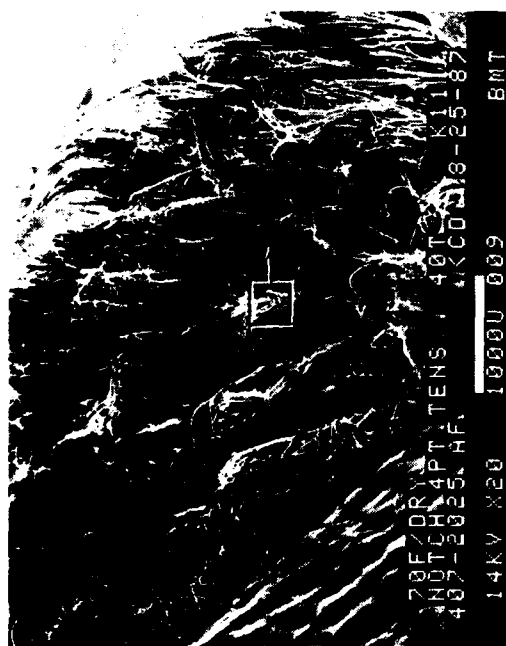
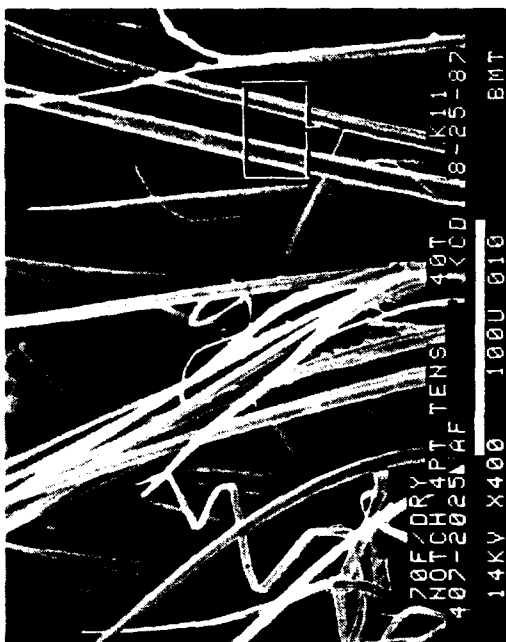
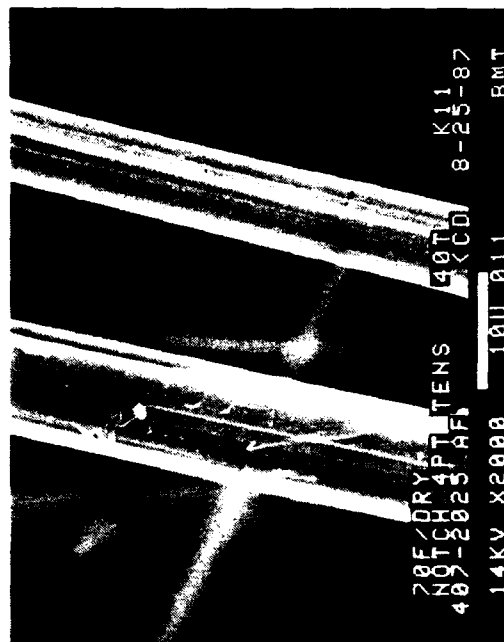
Figure 4.4-129. SEM Fractographs of 70 F/Dry, Translaminar Tension, 0/90 Fracture in Kevlar/Epoxy

Translaminar Tension, RT/Dry. Visual and optical observation revealed a broom-like fracture surface indicating extensive fiber-dominated fracture. Under SEM, the fiber/matrix interface showed a very smooth surface and the fiber ends showed no sign of any crack direction (Fig. 4.4-129).

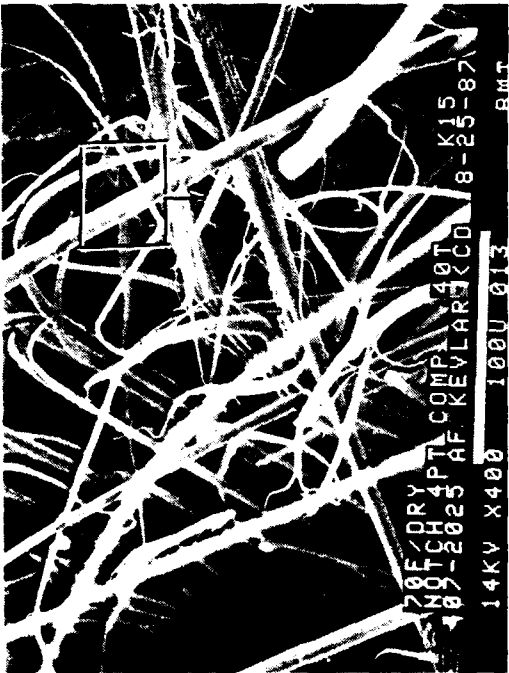
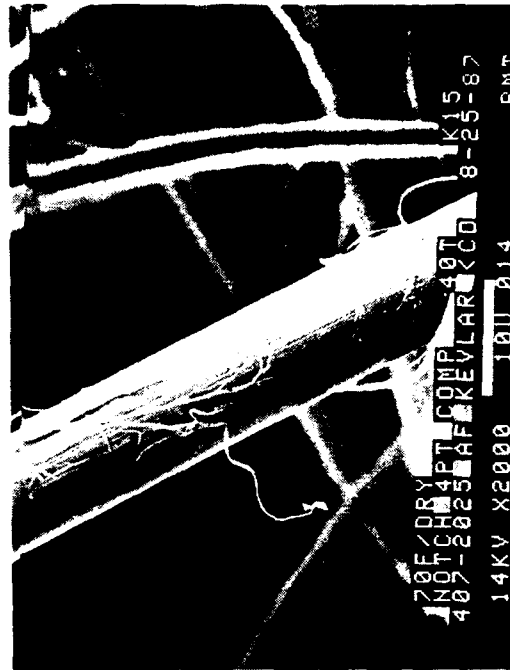
Figure 4.4-131. SEM Fractographs of 70 F/Dry, Translaminar Compression, 0/90 Fracture in Kevlar/Epoxy

Translaminar Compression, RT/Dry. Visual, optical, and SEM observations revealed a broom-like fracture surface with the protruding fibers twisted in all directions (Fig. 4.4-131).

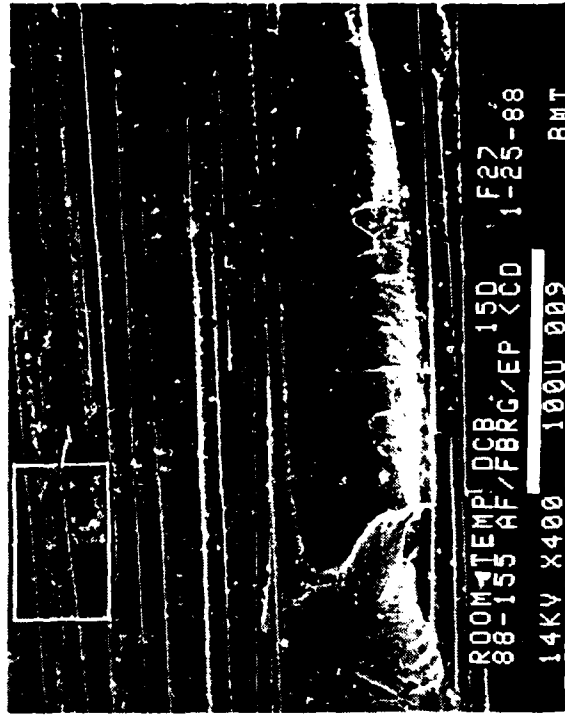
Figure 4.4-133. SEM Fractographs of Room Temperature, Interlaminar Mode I Tension Fracture in Fiberglass/Epoxy

Interlaminar Mode I Tension, RT/Dry. Visual observation of the fracture revealed a smooth, glassy surface. Optical photomicrographs were not taken because of the transparency of the fiberglass/epoxy. Cleavage markings, (rivermarks) typically seen in Mode I tension fractures of carbon fiber reinforced epoxies were observed under the SEM (Fig. 4.4-133). These features were usually observed at the nodes where the weaves overlap one another. The fiber/matrix adhesion appeared to be poor at some locations. This is due to the low inherent interfacial shear strength at the fiberglass/epoxy interface.

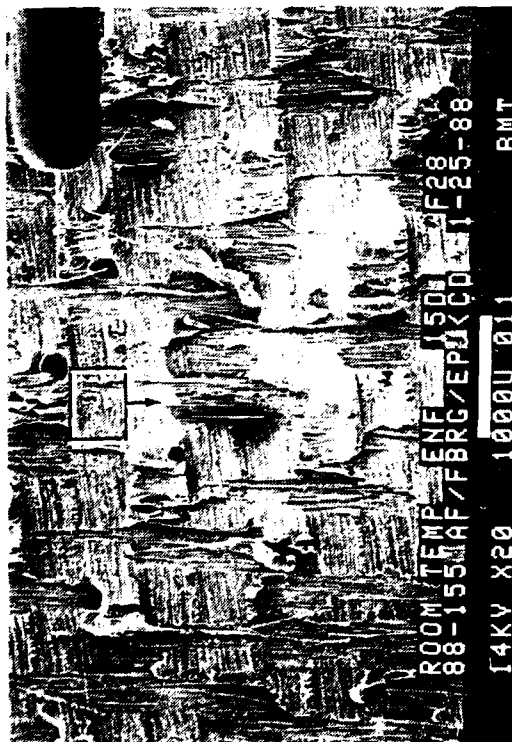
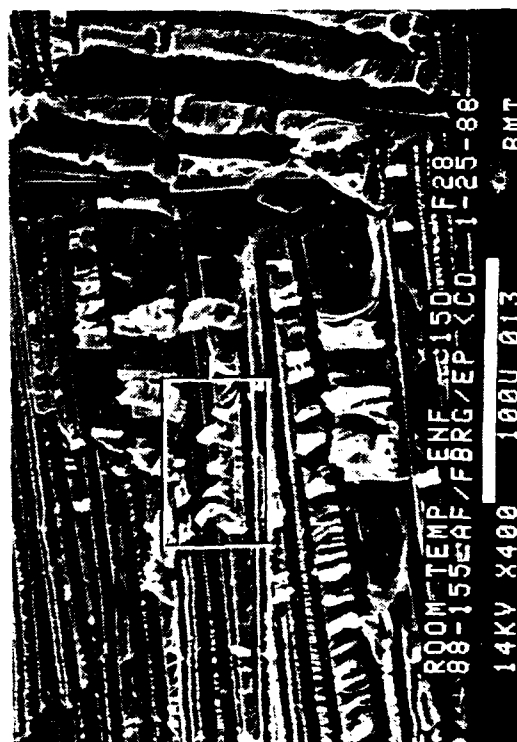
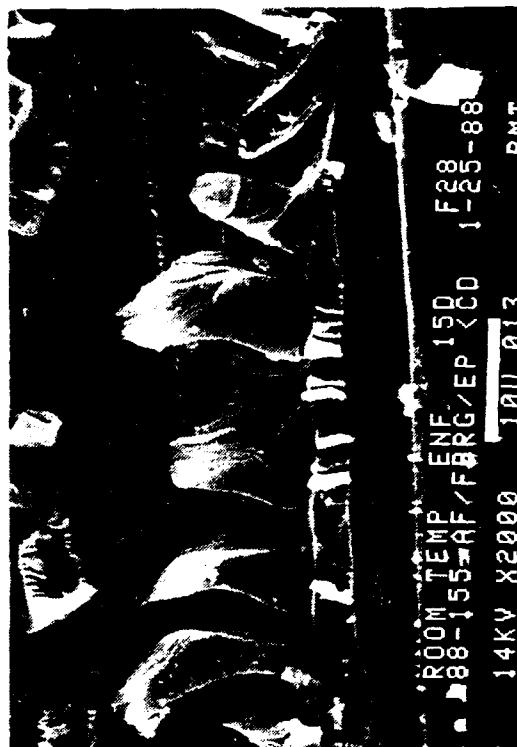
Figure 4.4-135. SEM Fractographs of Room Temperature, Interlaminar Mode II Shear Fracture in Fiberglass/Epoxy

SEM analysis (Fig. 4.4-135) revealed a rough fracture surface consisting of large numbers of hackles, which appear similar to the platelets seen in Mode II shear fractures of carbon fiber reinforced epoxies. There was poor adhesion of the fiber/matrix interface at some locations, is due to the low inherent interfacial shear strength.

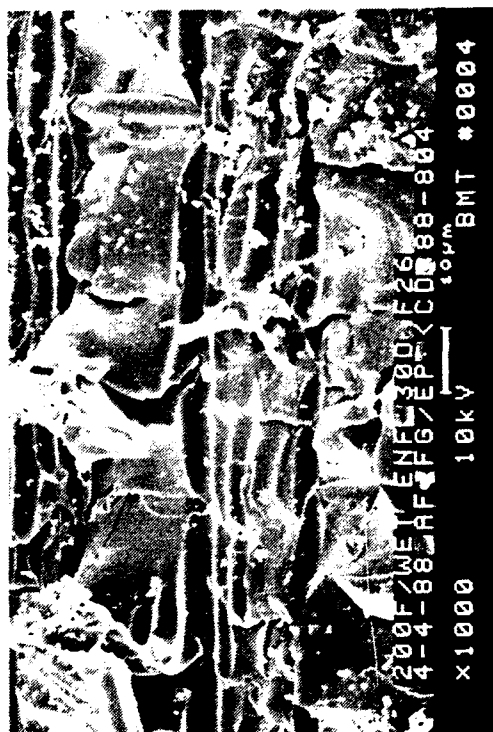
Figure 4.4-136. SEM Fractographs of 200 F/Wet, Interlaminar Mode II Shear Fracture in Fiberglass/Epoxy

Figure 4.4-136 shows the SEM fractograph of the fracture surface which appeared rough and showed hackles as observed in the RT/dry specimen. These hackles were much larger, but fewer in number than those seen in the RT specimens.

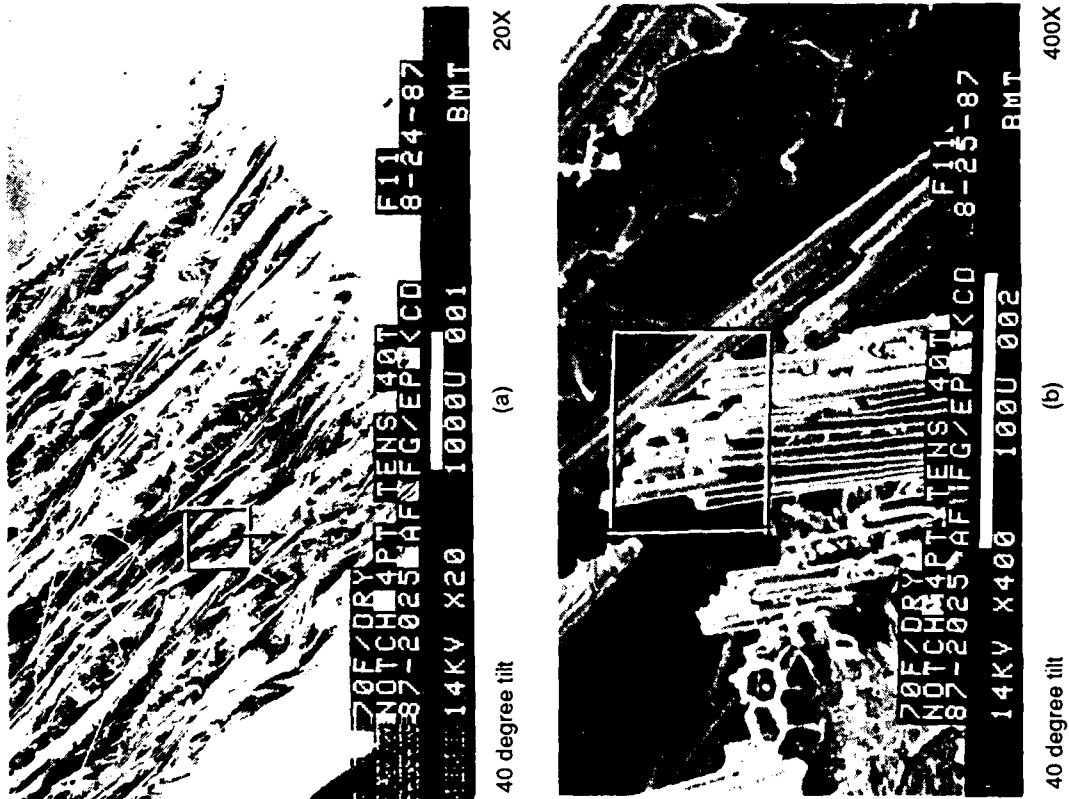
Figure 4.4-137. SEM Fractographs of 70 F/Dry, Translaminar Tension, 0/90 Fracture in Fiberglass/Epoxy

Translaminar Tension, RT/Dry. Visual and optical observation revealed a rough topography with protruding fibers of different lengths and directions (Fig. 4.4-137). The surface of the fiber/matrix interface was smooth due to the fibers being pulled away from the matrix. There was evidence of fiber dominated fracture in the large percentage of fiber pullouts. Similar to the carbon fibers, the radial patterns were

observed on the glass fiber ends and can be used to determine crack growth direction.

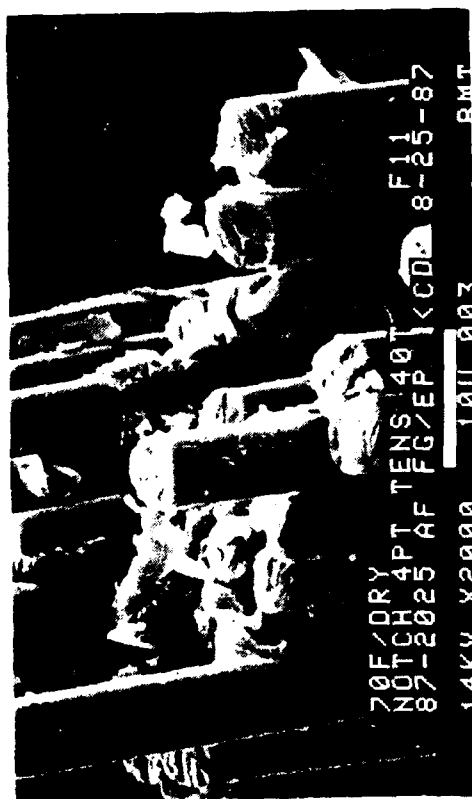
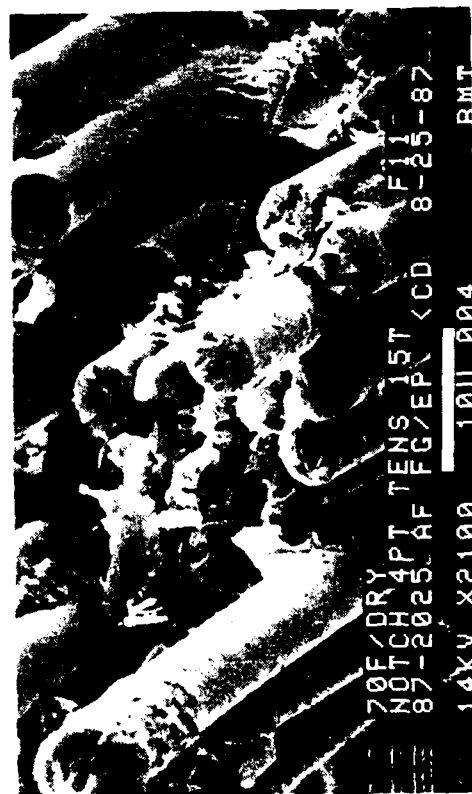
Figure 4.4-137. SEM Fractographs of 70 F/Dry. Translaminar Tension, 0/90 Fracture in Fiberglass/Epoxy (Concluded)

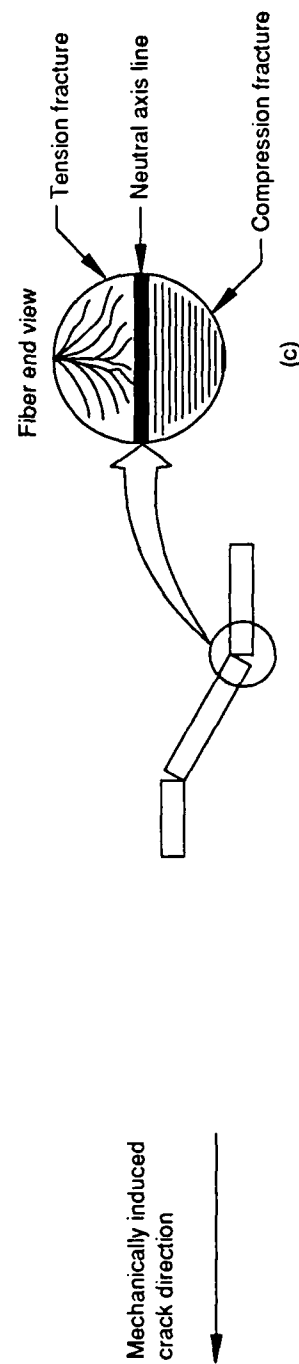
Figure 4.4-138. SEM Fractographs and Diagram of 70 F/Dry, Translaminar Compression Fracture in Fiberglass/Epoxy; Shown at 0 Degree Tilt

Translaminar Compression, RT/Dry. Visual and optical observations revealed a surface with uniform protruding fibers. The fiber/matrix interface showed good adhesion. Figures 4.4-138 and 4.4-139 show the SEM fractographs. A neutral axis line dividing the tension and compression regions on the fiber ends was observed.

Fiber microbuckling

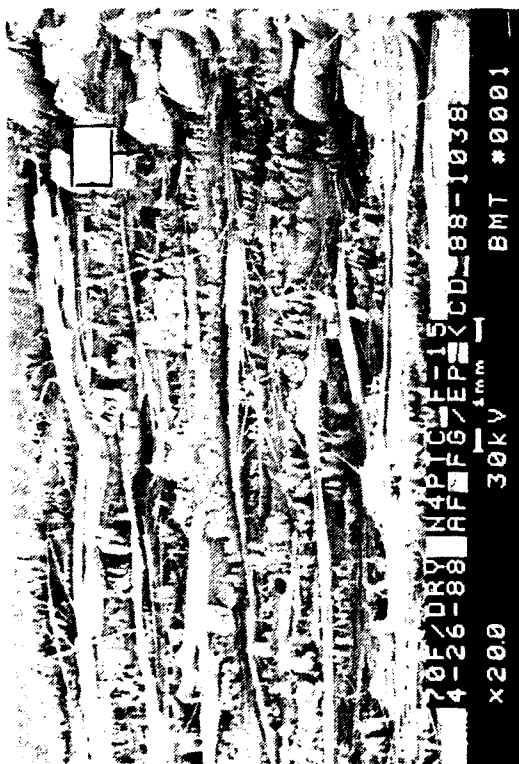
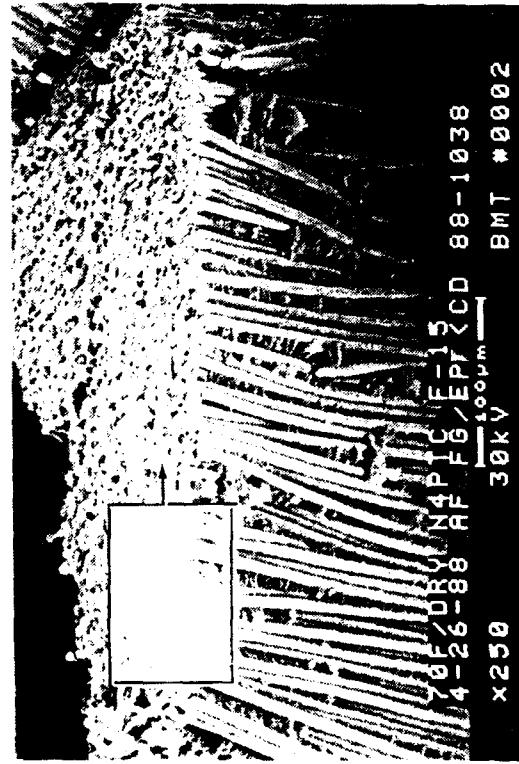
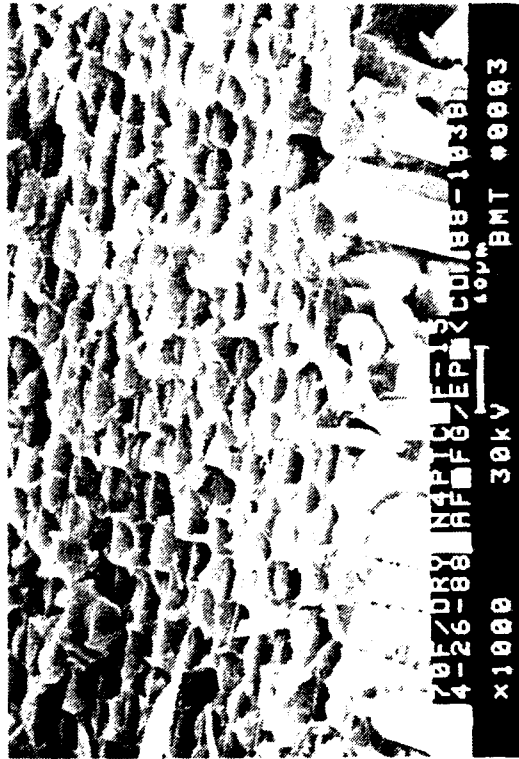
Figure 4.4-139. SEM Fractographs and 70 F/Dry, Translaminar Compression Fracture in Fiberglass/Epoxy; Shown at 45 Degree Tilt

Mechanically induced
crack direction

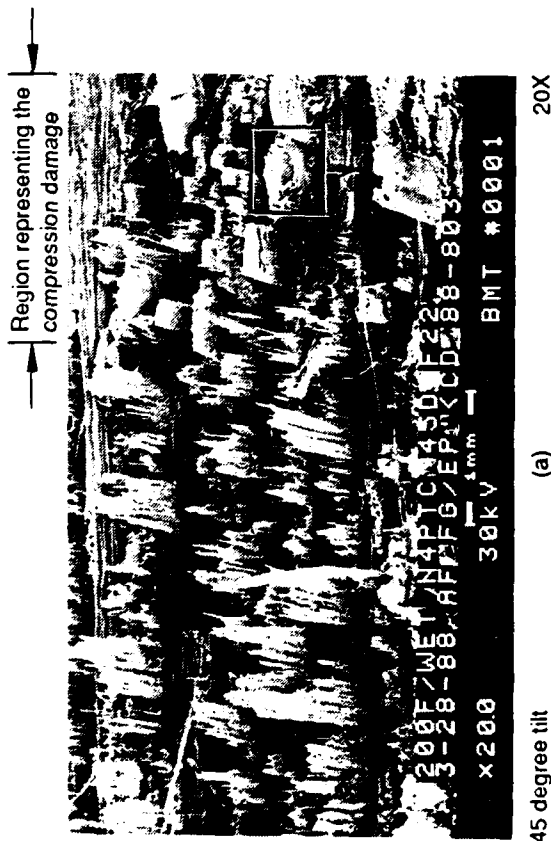
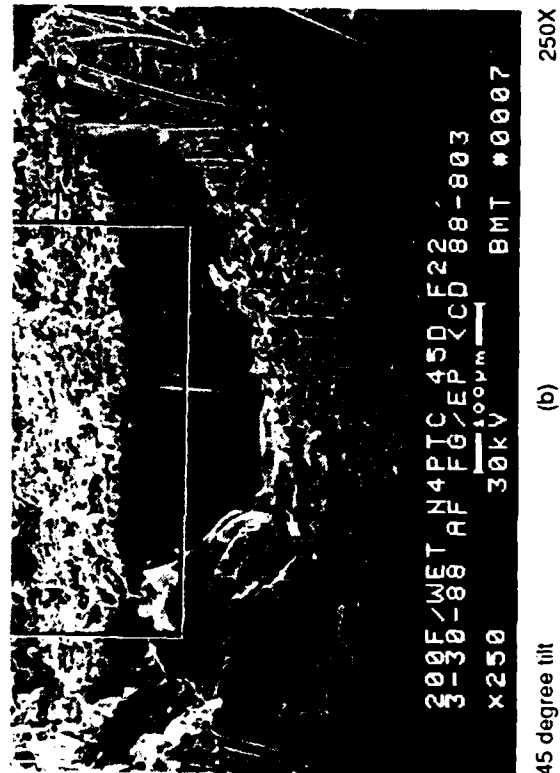
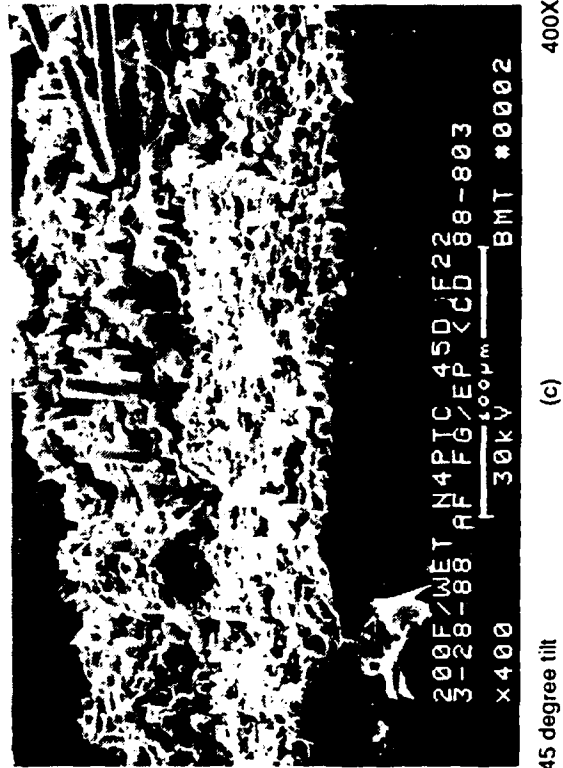
Figure 4.4-140. SEM Fractographs of 200 F/Wet, Translaminar Compression Fracture in Fiberglass/Epoxy; Shown at 45 Degree Tilt

Translaminar Compression, 200°F/Wet. Optical observation of the 200°F/wet specimen revealed a fracture surface like that typically seen in RT/dry translaminar compression specimens. The compression damage occurred in the region just outside of the notch. The typical fracture of a translaminar compression specimen exhibited a flat surface with "chop" marks on the fiber ends (Fig. 4.4-140). Compressively fractured fiber ends show two distinct regions separated by a neutral axis line. This line does not represent any kind of crack direction (Fig. 4.4-141).

Mechanically induced crack direction

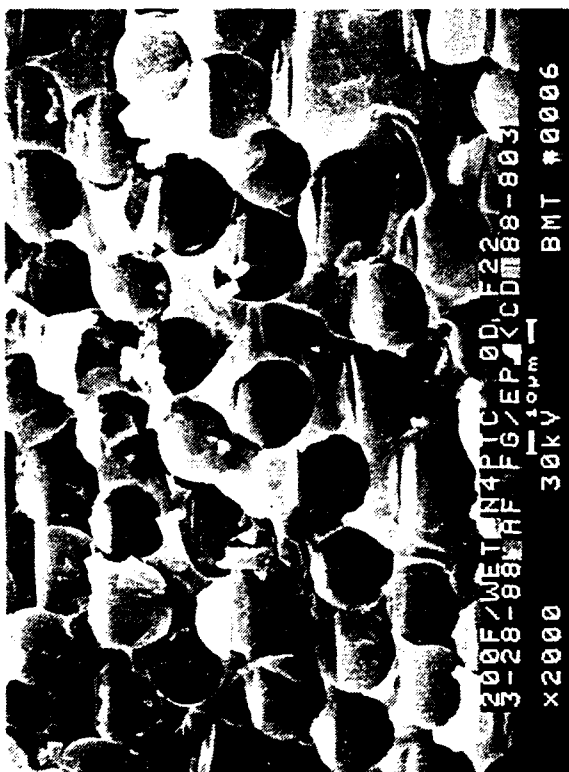
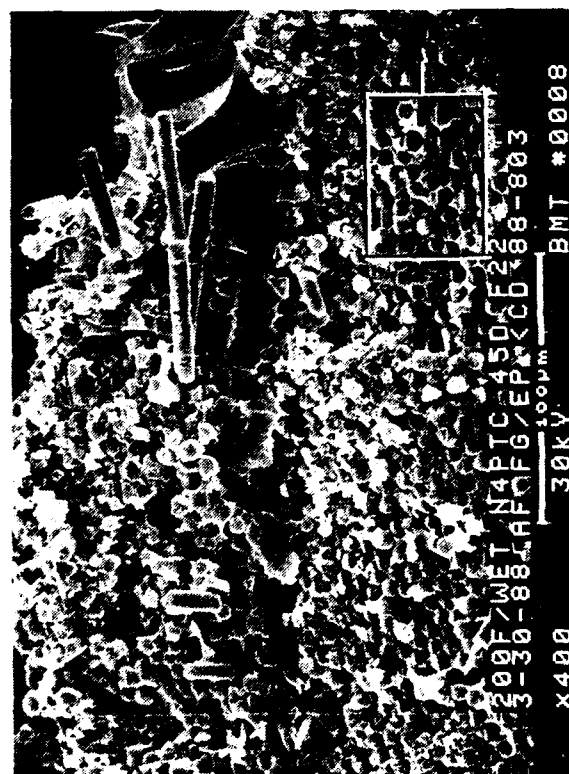
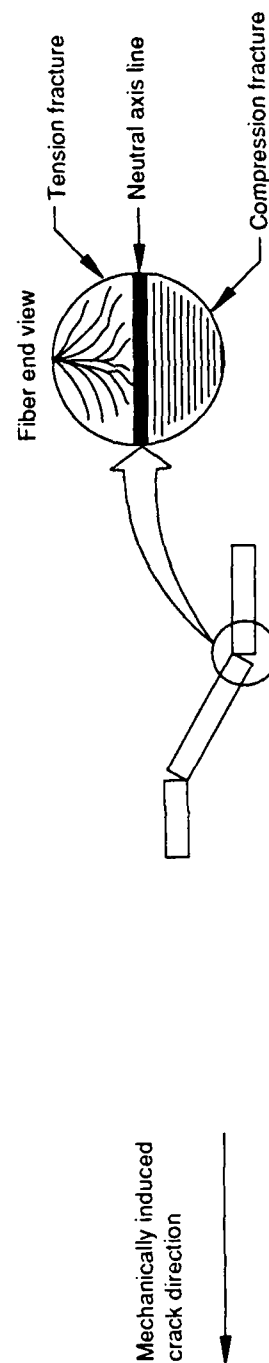
Figure 4.4-141. SEM Fractographs of 200 F/Wet, Translaminar Compression Fracture in Fiberglass/Epoxy; Higher Magnification

Fiber microbuckling

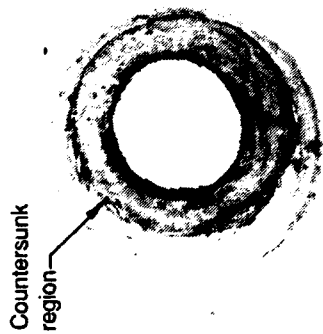
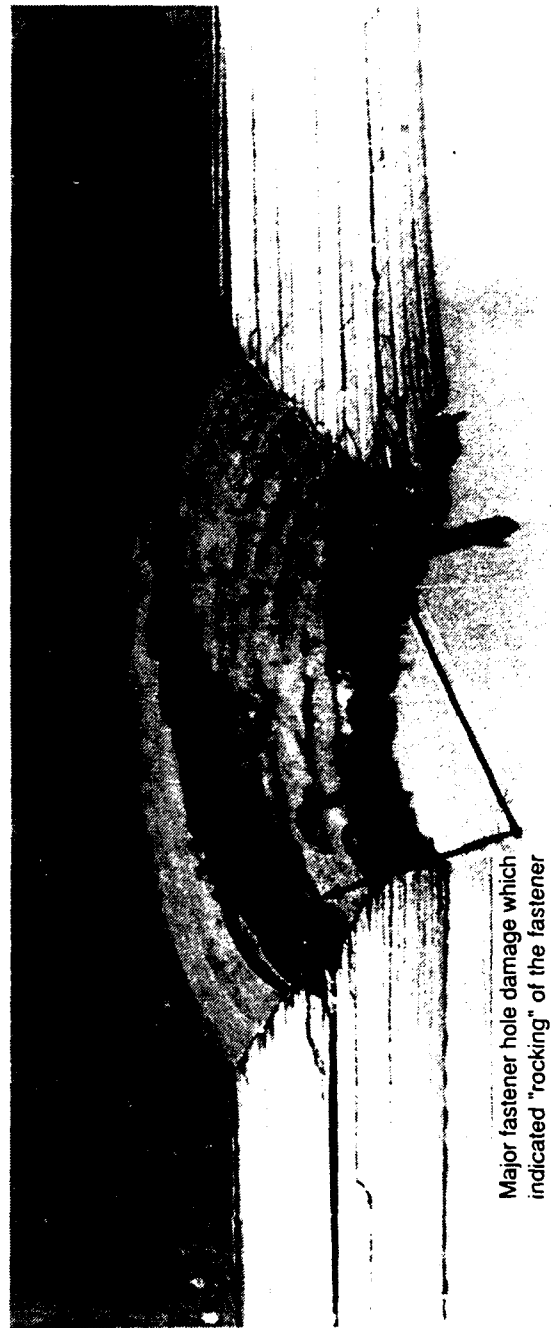
Figure 7.4-3. Damage in Fastener Hole Loaded Under Shear

In conjunction with stress analysis, visual examination was performed using fastener hole damage as evidence to determine the loading condition experienced by the panel during the test. The key evidence was the depth and elongation of the hole. In general, hole elongation indicates shear-type loading in which the head and the shank of the fastener tilt at an angle to the hole. Figure 7.4-3 illustrates the damage of a typical shear loaded fastener hole. The damage seen in the countersunk region of the fastener

hole was created by the fastener head which dug into the laminate due to the test load. In contrast, tension loaded fastener holes did not show any sign of elongation, retaining their circular shape (Fig. 7.4-4). The fastener head dug beyond the countersunk region causing severe delamination near the inner edge of the hole. Figure 7.4-5 shows the mapping of the fastener hole damage. From the mapping, it was determined that Region A of the panel was loaded under tension and shear. However, Region B seemed to have been securely fastened to a fixed structure as evidenced by the lack of fastener hole damage in that portion of the panel.

The fastener hole damage observed in certain locations on the test panel indicated that some of fasteners were not designed for the particular application. The fasteners on the end of Region A experienced a substantial amount of shear loading compared to the rest of the panel. The recommendation would be to examine the hole damage and make appropriate changes in the fasteners (i.e., change to shear or tension) to accommodate the load conditions experienced during the initial testing. Due to the fact that the mechanical test was unknown, recommendation for design improvement is difficult.
